TECHNICAL & SAFETY COMMITTEE INTERNATIONAL PARACHUTING COMMISSION (FAI)

SERVICE BULLETIN SB271107

ICON CONTAINER GROMMET INSPECTION Issue Date : November 27, 2007

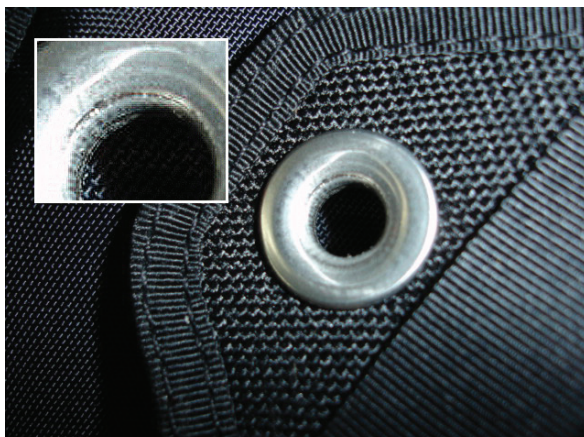
Background: A report back from the field revealed that there were some damaged Grommets on an ICON Container. The ICON was returned to the manufacturer where it was determined that the Grommets had been damaged by the Grommet Press.

The Damage can be seen on the inside of the Grommet where the Closing Tool has scratched the Inside Surface of the Grommet. The seating of the Grommet needs to be inspected to ensure correct and flush seating of the Grommet.

1. Damaged Grommet
see damage on inner ring of grommet

This could well be an isolated incident, but as a matter of precaution Aerodyne is recommending all Grommets on the ICONs listed in the Identification paragraph above be Inspected.

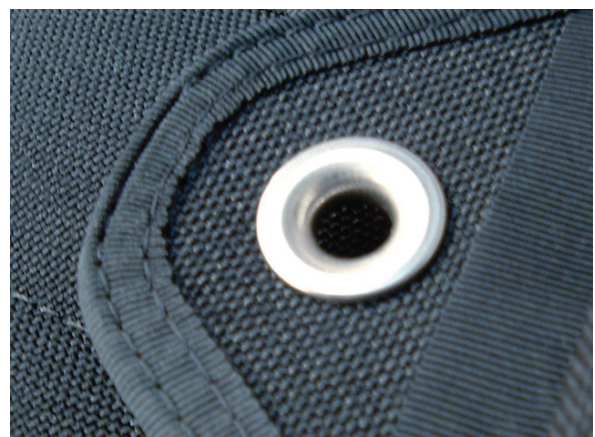
1. Undamaged Grommet
