**TECHNICAL & SAFETY COMMITTEE**  
**INTERNATIONAL PARACHUTING COMMISSION (FAI)**

<p><b>Technical &amp; Safety Information Notice No.</b></p>	<p><b>01/2009</b> <span style="float: right;"><b>W.N. 22</b></span></p>
<p><b>Date of Issue</b></p>	<p><b>28 January 2009</b></p>
<p><b>Subject Matter and Applicability</b></p>	<p>Following a riser failure on a PA Talon, the Australian Parachute Federation’s Director Rigging, Jo Chitty, issued the following notice. This notice is of mandatory status for APF members, and it is being distributed by the Technical &amp; Safety Committee of IPC to alert skydivers worldwide to the issues concerned.</p> <hr/> <p style="text-align: center;"><b>IMPORTANT ANNOUNCEMENT FROM THE DIRECTOR OF RIGGING, AUSTRALIAN PARACHUTE FEDERATION.  MANDATORY INSPECTION OF ALL 3-RINGS PRIOR TO NEXT USE</b></p> <p><b>RISER FAILURE</b>  On Sunday 18 January 2009, a <b>PA Talon</b> riser failed on opening. It was the left riser with RSL fitted. The reserve was deployed into the trailing main by the RSL resulting in a main reserve entanglement. Fortunately and with luck the jumper managed to attain sufficient reserve inflation to survive the landing with broken bones in his

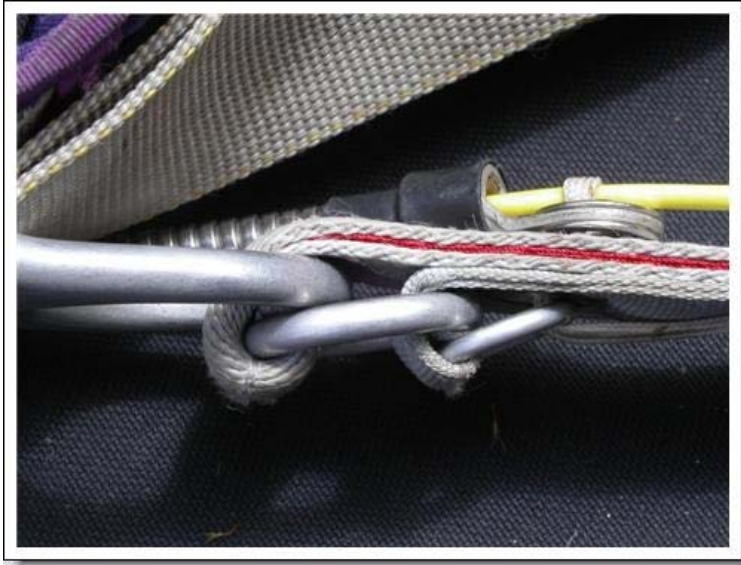
In August 2001 the APF promulgated APF Service Bulletin No APF010801-A 3-ring Inspection And Maintenance. The inspection, Part A, is designated **Mandatory**. This rig's reserve had been packed six times since the service bulletin was published, and numerous other times when the main was packed and possibly the 3-rings serviced. Had the service bulletin been applied it would have highlighted that the riser did not meet the criteria of the service bulletin; **the locking loop was too short.**

Due to the unique method of construction on this riser of bar-tacking across the loop it is probable that over a period of jumps some of the stitches had broken, due to the excessive load applied by the short locking loop until on this jump they failed completely allowing the loop to pull out of the riser, releasing it. It is impossible to visually inspect the stitching as it is covered by the confluence wrap; failure comes without warning signs. There was no kink in the left cutaway cable to warn of excessive loading. To prevent a similar event occurring especially when an RSL is fitted the following must occur.

**MANDATORY INSPECTION** in accordance with APF Service Bulletin [APF010801-B](#)\* Issued 23<sup>rd</sup> January 2009 of all 3-ring riser assemblies before the next jump. Inspection to be noted on reserve packing card and marked on inside of front riser with APF010801-B using a fine tip paint pen so it will be visible even if the risers are black.

Inspection to be carried out by a packer B or higher rating. If there is any doubt the assembly should be checked and evaluated by a rigger.

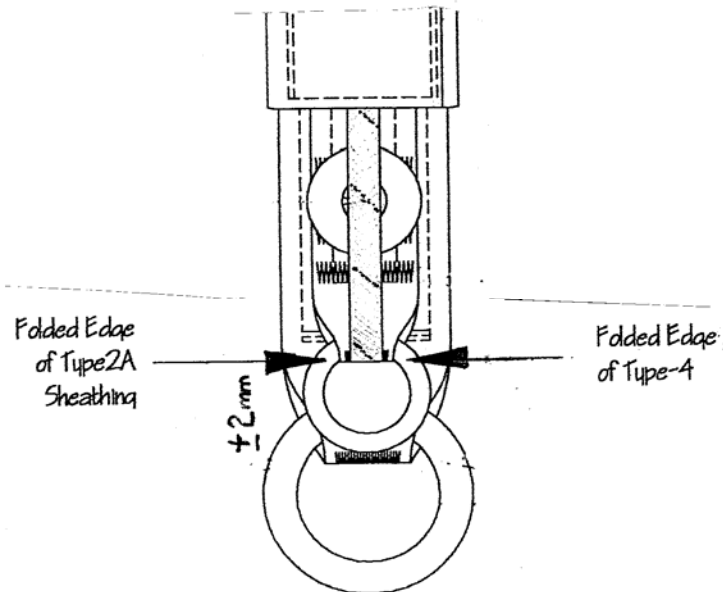
On all solo rigs and all types of riser style, one inch type 17 mini rings, type 8 mini rings and standard type 8 with the larger rings, the length of the locking loop should be level (+/- 2mm) with the end of the fold of the webbing that retains the small ring when the riser is laid flat with some tension applied to the small ring.

It is normal for new type 17 mini risers to be tight to interlock the rings, this is because they become more pliable with use, but the locking loop must still allow the housing some play and not pull the small ring against the riser, see side view on service bulletin.

**Typical view of locking loop length**
