**TECHNICAL & SAFETY COMMITTEE**  
**INTERNATIONAL PARACHUTING COMMISSION (FAI)**

| <p><i>Technical &amp; Safety Information Notice No.</i></p> | <p>02/2009 <span style="float: right;">W.N. 23</span></p> |
| <p><i>Date of Issue</i></p> | <p>09 February 2009</p> |
| <p><i>Subject Matter and Applicability</i></p> | <p><b>Sun Path Products Inc.</b><br/> <b>SERVICE BULLETIN #SPSB005, dated February 3 2009</b><br/> <b>Re JH1013 (HIP RING MLW) AND JH1014 (4 RING MLW) RING DAMAGE</b></p> <p><b>SUBJECT: HIP RING AND 4 RING MAIN LIFT WEB INSPECTIONS</b></p> <p><b>IDENTIFICATION:</b><br/> ALL SPORT JAVELIN ODYSSEY HARNESS/CONTAINERS WITH <i>HIP RING OR 4 RING</i> MAIN LIFT WEB, WITH DATE OF MANUFACTURE BETWEEN <b><u>SEPTEMBER 2008 AND DECEMBER 2008.</u></b></p> <p><b>BACKGROUND:</b><br/> It has been brought to our attention that the hip ring on JH101-3 (Hip Ring Only) and JH101-4, (4-Ring) main lift webs, may have been struck by the needle used for installing the 5 cord harness stitching. This needle strike on the hip ring may cause damage to the Type 12 buffer, 5 cord stitching and possibly the Type 7 webbing. As a precaution, <b><u>a mandatory inspection of the hip rings is required for a

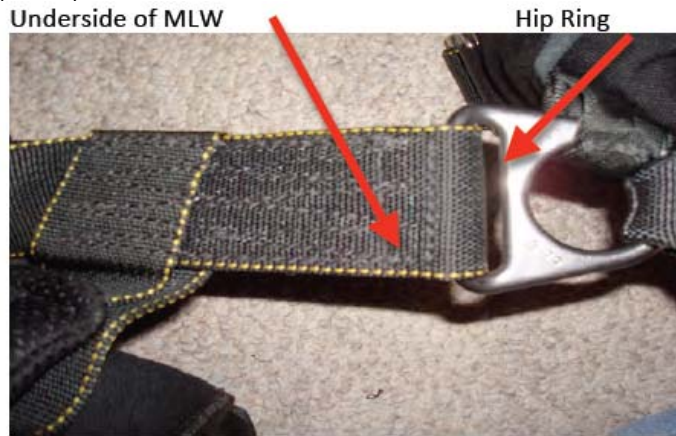
Turn Main lift web over, to expose the underside of the MAIN LIFT WEB (MLW).

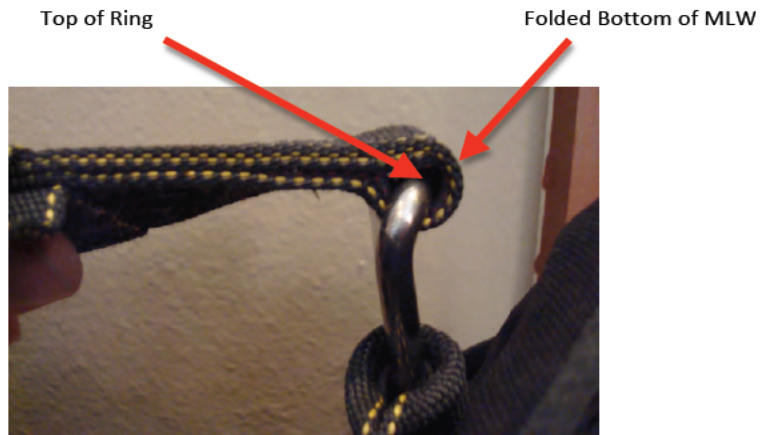
5. Rotate Hip ring and leg pad 90 degrees downward as to expose the top of the ring to the inside of the folded bottom end of the MLW webbing, as shown below.

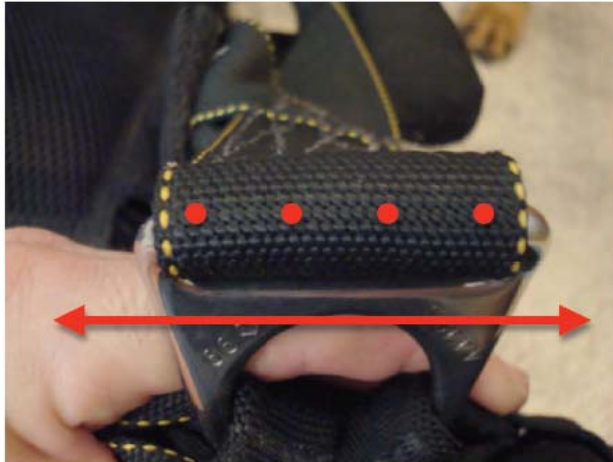
**FEEL HERE FOR DAMAGED RING INSIDE WEBBING. DAMAGE WILL MOST LIKELY BE ALIGNED WITH THE BOTTOM POINTS OF THE 4 POINT STITCH PATTERN.**

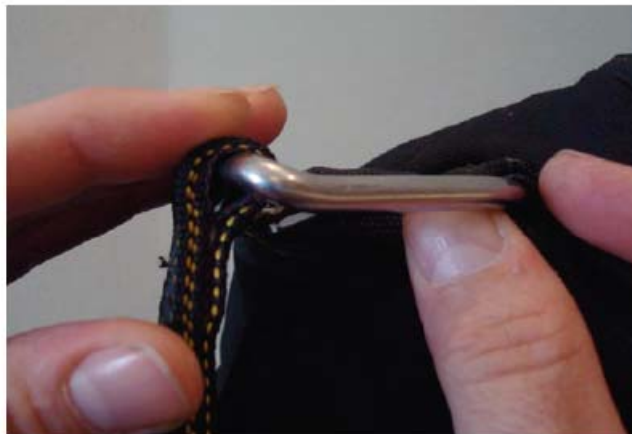
**BACK AND FORTH/ SIDE TO SIDE MOTION**

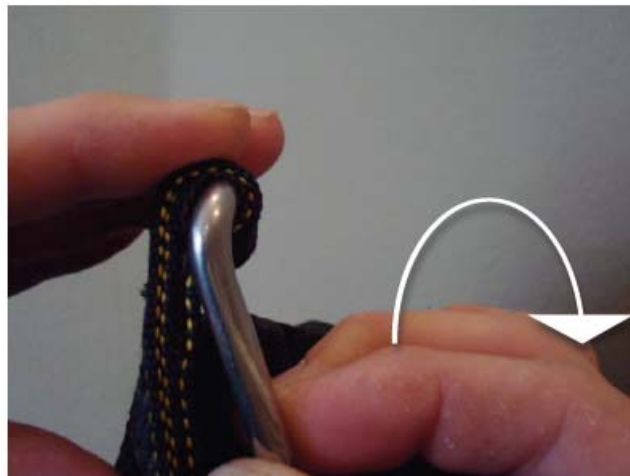
**ROTATE DOWWARD**
